**PRELIMINARY ENVIRONMENTAL SITE ASSESSMENT - PHASE I UPDATE  
AND SUBSURFACE ASSESSMENT - PHASE II**

Western Portion of Huntington Beach Mall  
Former Montgomery Wards Facility  
7777 Edinger Avenue  
Huntington Beach, California

CE Job No. EP102-2345

September 2005

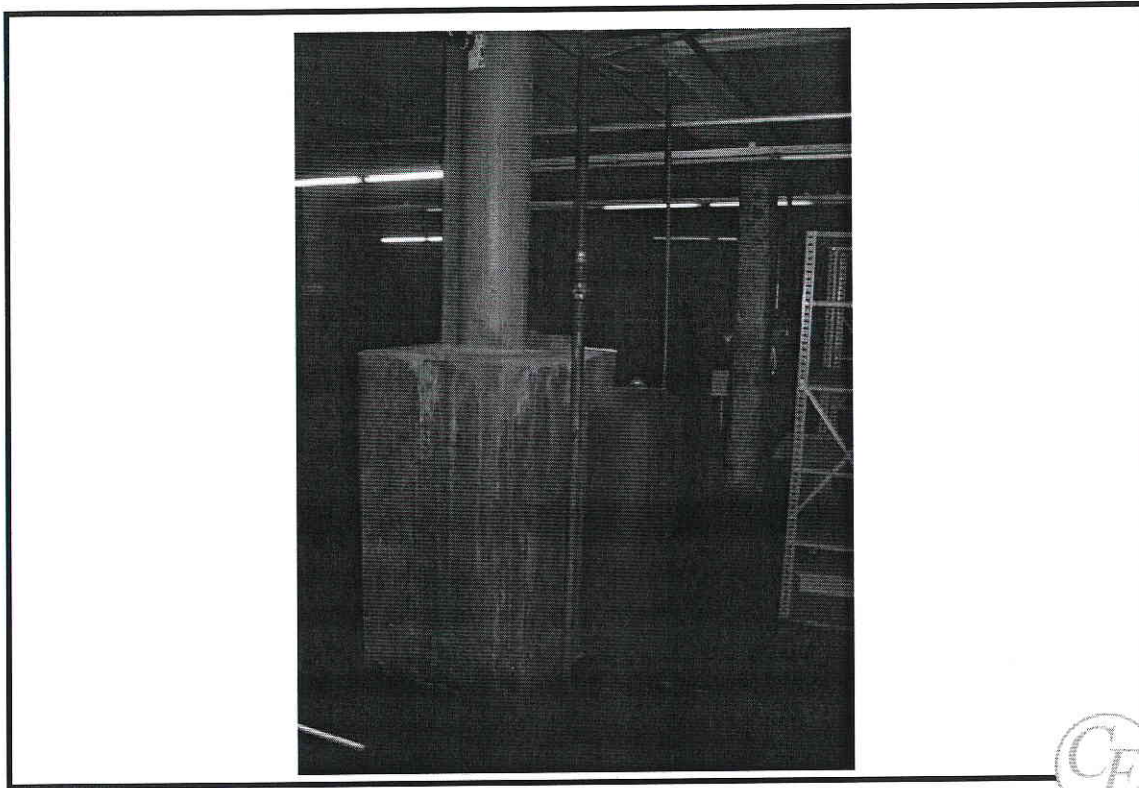
Hydraulic hoists are located within the vacant Montgomery Ward Automotive facility. Some of the hydraulic oil reservoirs are located above ground within the basement of the automotive facility. No leaks of hydraulic oil were observed from the hydraulic oil reservoirs observed within the basement of the structure. Minor oil staining was observed on the concrete surface near two hydraulic hoists.

Hydraulic lift-basement view.  
7777 Edinger Avenue-Montgomery Wards, Huntington Beach, CA

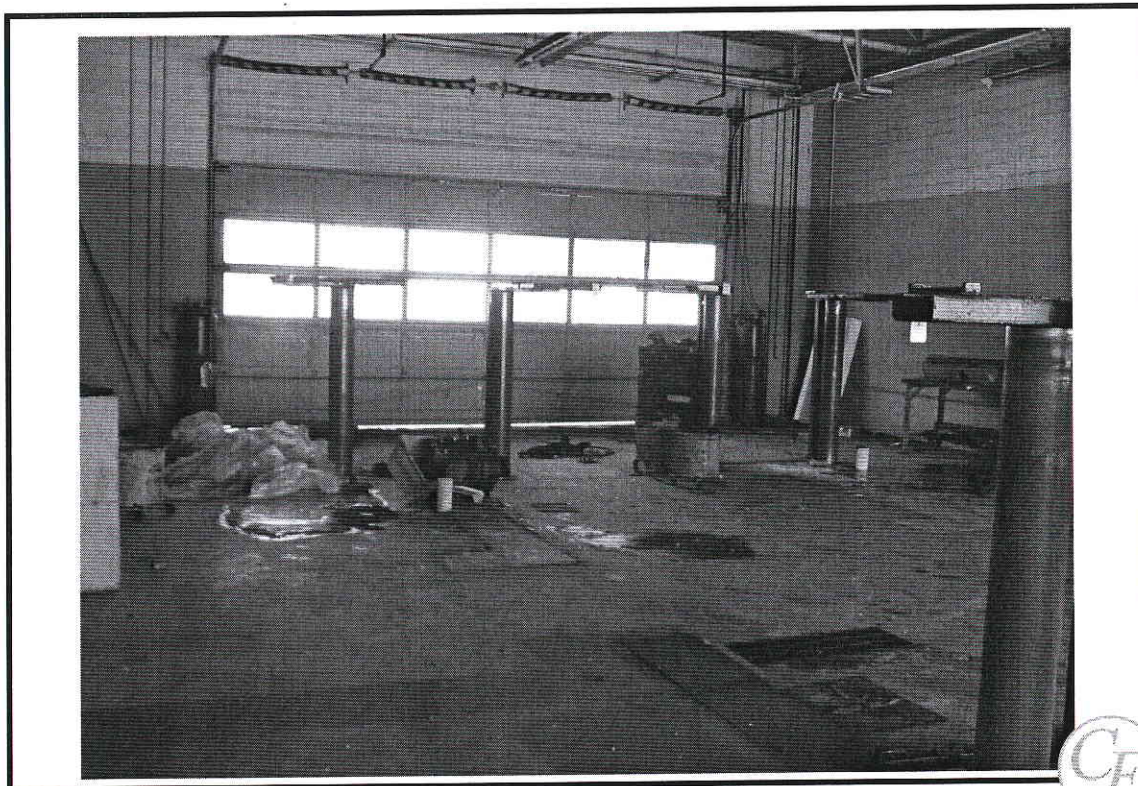
Hydraulic lifts - auto center.  
7777 Edinger Avenue-Montgomery Wards, Huntington Beach, CA

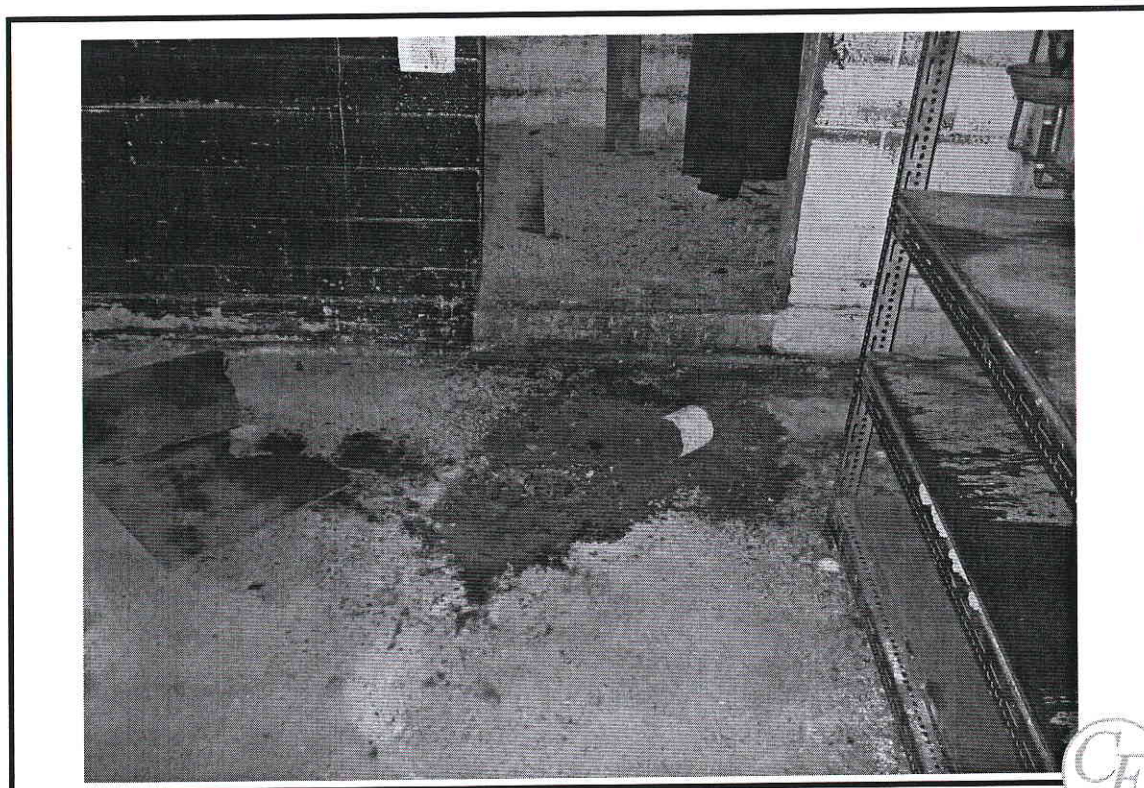
Automotive batteries were previously stored and serviced within the northern portion of the former Montgomery Ward Automotive Center structure. The concrete flooring located within the battery storage area is significantly degraded. The concrete flooring appeared to be etched from spillage of battery (sulfuric) acid. Areas of oil stained concrete were also observed within the automotive repair facility. No other evidence of staining or residue was observed on the subject property at the time of the site reconnaissance.

Battery room - auto center.  
7777 Edinger Avenue-Montgomery Wards, Huntington Beach, CA

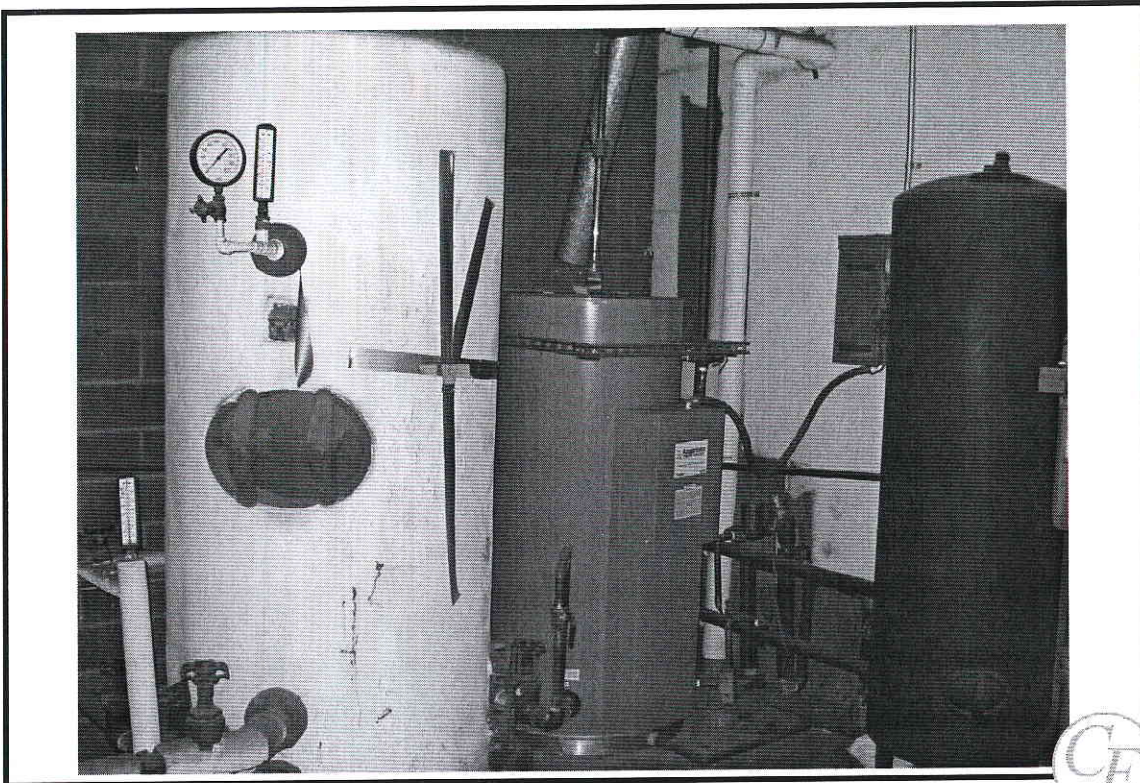
View of insulation, hot water system in department store.  
7777 Edinger Avenue-Montgomery Wards, Huntington Beach, CA

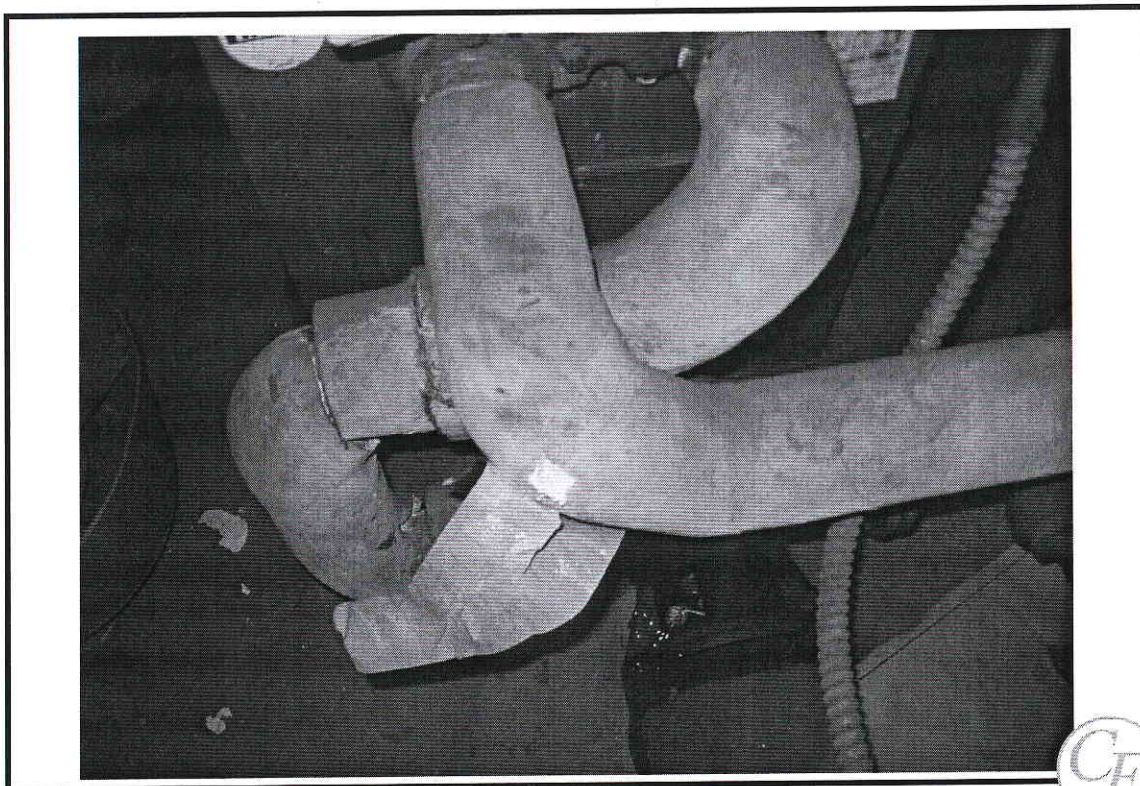
View of pipe insulation in department store.  
7777 Edinger Avenue-Montgomery Wards, Huntington Beach, CA

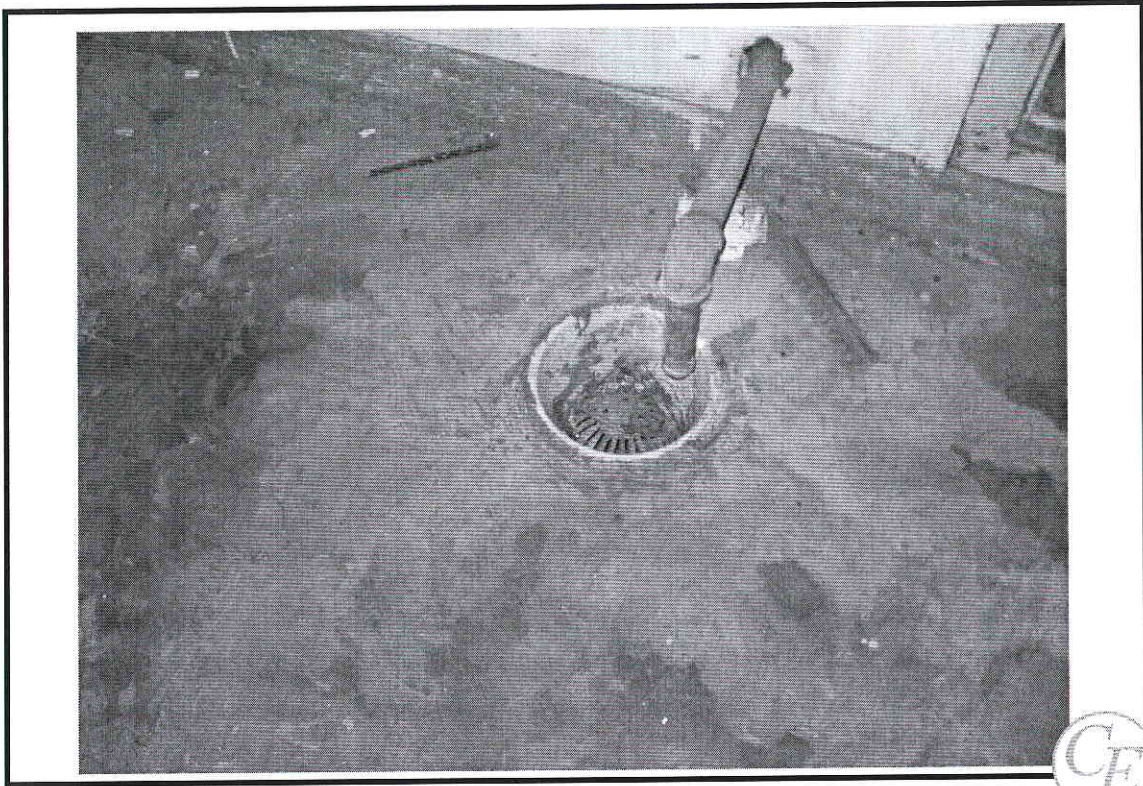
View of floor drain inside department store.  
7777 Edinger Avenue-Montgomery Wards, Huntington Beach, CA

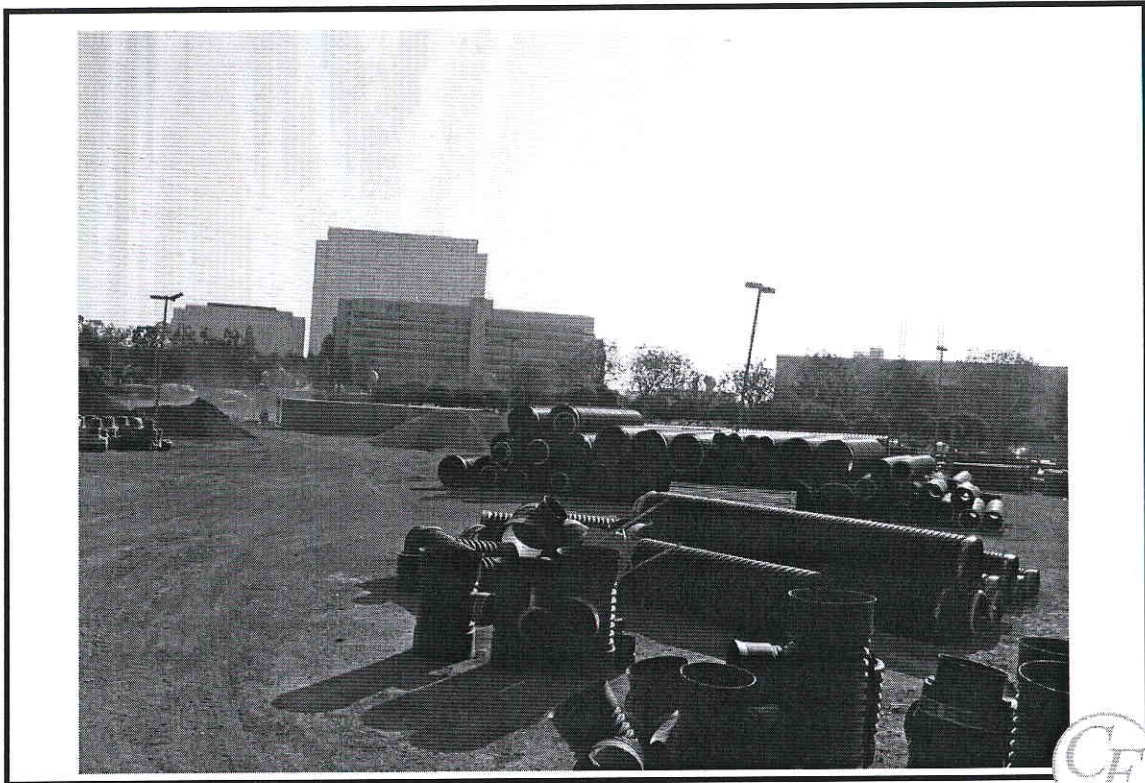
View of material storage area on the northwest portion of property.  
7777 Edinger Avenue-Montgomery Wards, Huntington Beach, CA

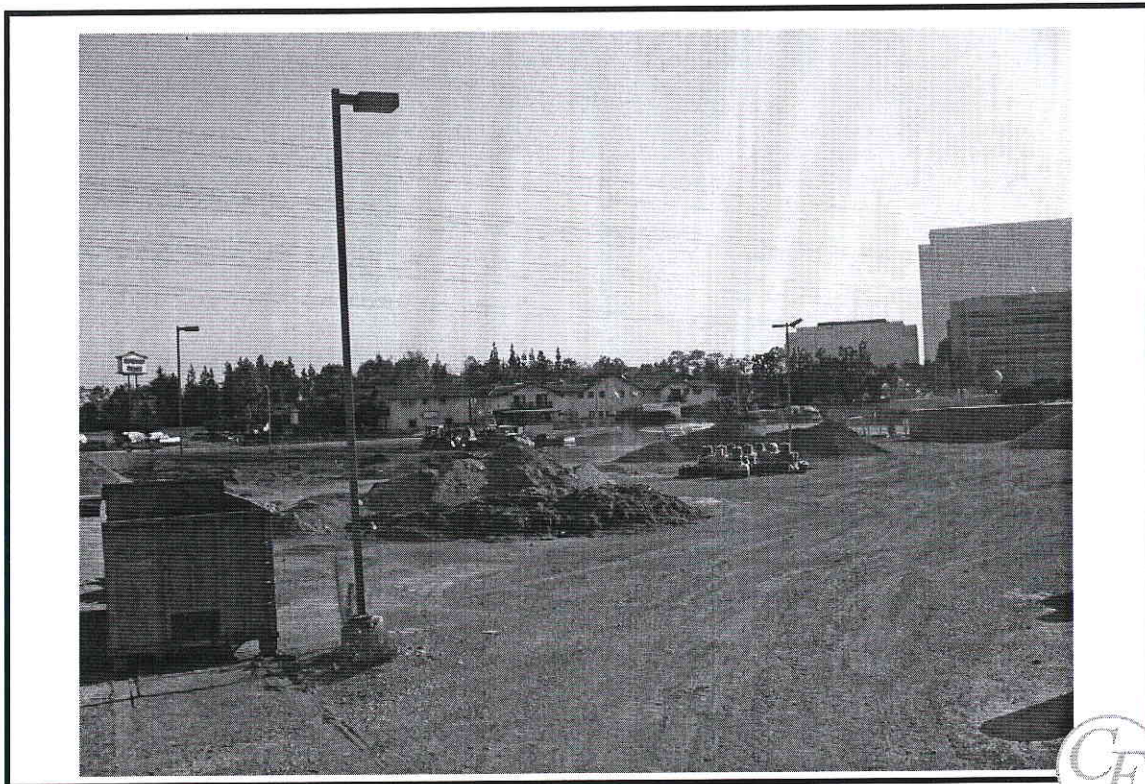
View of material storage area on the northwest portion of property.  
7777 Edinger Avenue-Montgomery Wards, Huntington Beach, CA
